This errata sheet provides updated information about known device issues affecting Arria® II GX devices.

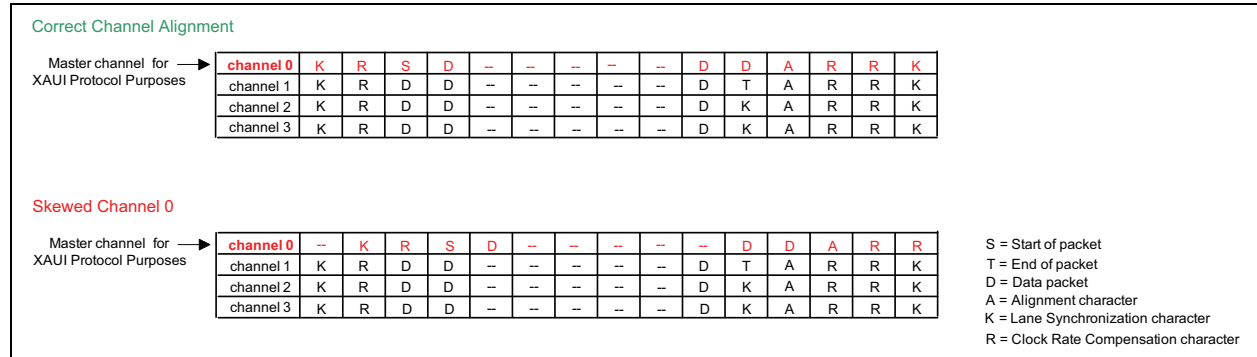
Figure 4. Rate Matcher FIFO Skew

In XAUI functional mode, the data out of the channel 0 Rate Match FIFO may be shifted by one byte with respect to the data of the other three channels. This causes incorrect idle ordered set conversion, resulting in incorrect received parallel data. This issue happens only during initialization or receiver channel reset (assertion of `rx_analogreset` or `rx_digitalreset`).

Figure 4 shows the channel skew.

Altera provides a soft IP solution and associated documentation, available for download at: www.altera.com/patches/xau-softip/xau-softip-fix-reva.zip. This soft IP should be integrated into the XAUI receiver data path. This issue is fixed in production devices.
