ES_LPC3220

Errata sheet LPC3220

Rev. 9 — 1 June 2011

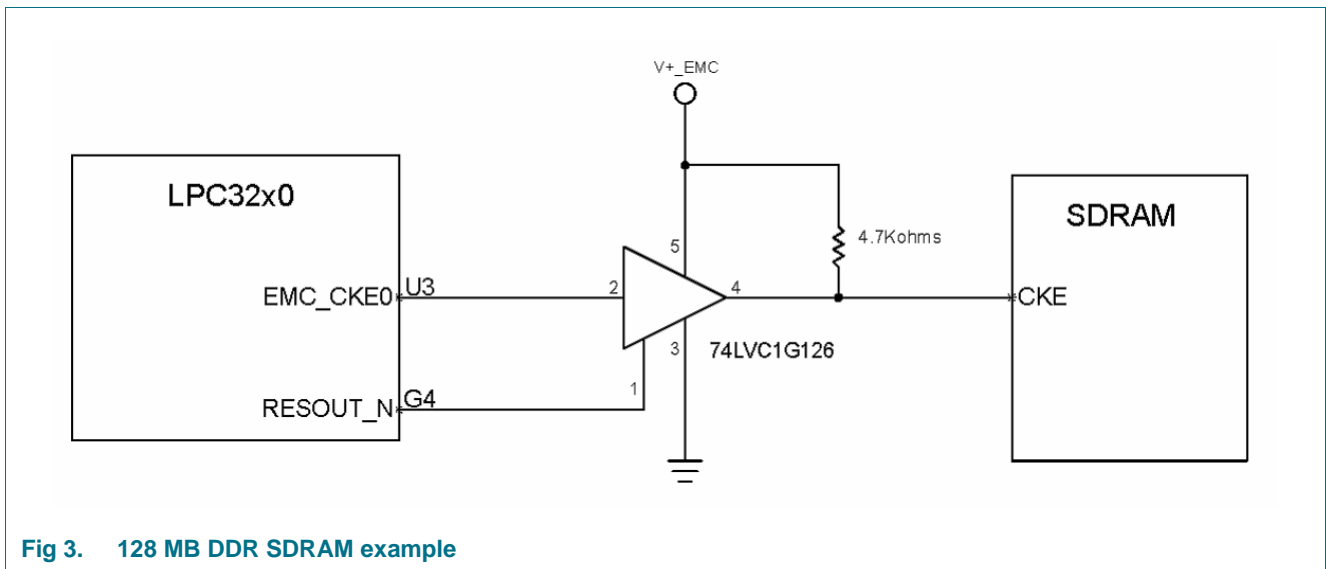
Fig 3. 128 MB DDR SDRAM example

If the LPC3220 is reset during an SDRAM access, the SDRAM clock and clock enable will be immediately de-asserted. If the de-assertion occurs during the period of time the SDRAM is driving the data bus, the SDRAM will hold that state until the next clock occurs at the SDRAM clock input when the clock enable is active. However, the LPC3220 won't deliver the clock and clock enables until software actually sets up the EMC state to do this, so the SDRAM will remain in the data assertion state on the data bus while the LPC3220 tries to boot.

When the chip attempts to load boot code from NOR FLASH after reset, the correct signals are asserted to the NOR FLASH device and the NOR FLASH device places its data on the data bus. But if the SDRAM is still driving the bus, the NOR FLASH device and SDRAM device are in contention and the data will not be read correctly into the LPC3220. In this situation, the LPC3220 will fail to boot.

If booting from NOR FLASH is a requirement, the simple circuit shown in [Figure 3](#) can be used to clear the SDRAM state at system reset. This will not change the normal functioning of the LPC3220 EMC or SDRAM operations. If SDRAM devices are also present on the 2nd SDRAM chip select, a similar circuit will be needed for those devices using EMC_CKE1.

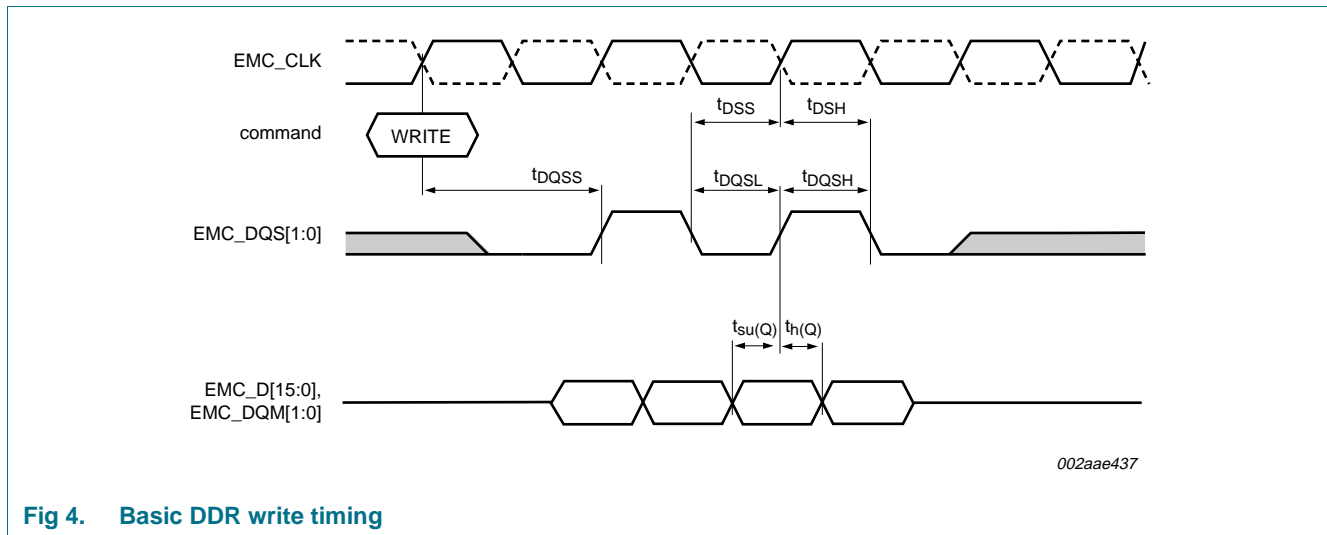
Fig 4. Basic DDR write timing

For DDR writes the LPC3220 drives the EMC_DQS[1:0] earlier in the data valid window than center aligned. With the EMC_CLK at 133 MHz this produces a minimum set-up time between the EMC_D[15:0] and EMC_DQS[1:0] of 600 ps across silicon process, voltage and temperature. Test conditions are with the EMC buffers set to fast slew rate driving 2 inches of 50 Ω transmission line and 10 pF load capacitance. DDR memories specify EMC_D[15:0] to EMC_DQS[1:0] set-up time minimum as 400 ps. This leaves 200 ps set-up time margin due to customer specific load and PCB layout implementation. See the LPC3220_30_40_50 data sheet for the complete range of DDR data output set-up time, $t_{su(Q)}$, and data output hold time $t_{h(Q)}$ times.
